**GEOLOGIC REVIEW AND SOILS
ENGINEERING REPORT
GEAR ESTATES
1156 18 ROAD
FRUITA, COLORADO**

**Prepared For:
TreyTyn Homes**

**August 31, 2023
Job No. 4812**

Subject: Geologic Review and Soils Engineering Report
Gear Estates
1156 18 Road
Fruita, CO 81521

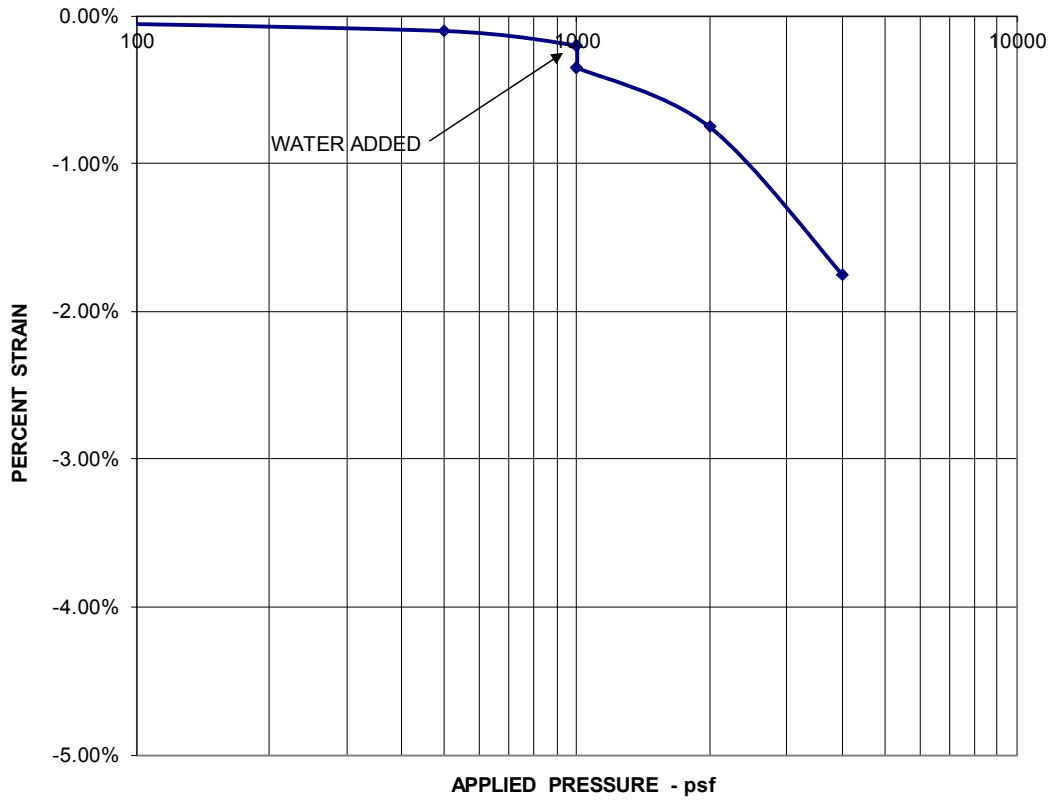
Job Number	Job No.4812 Spocket Subdivision	
Sample Source	TP-1 at 2 ft	
Sample Description	CL	
Natural Dry Density	102.5 pcf	90% Relative Compaction
Natural Moisture Content	11.1%	-3.7% From Optimum
Saturated Moisture Content	20.6%

While the soil types are very similar, their mechanical properties are quite different due to their natural moisture content. When the native soils are properly moisture conditioned and compacted, they form a suitable foundation material.

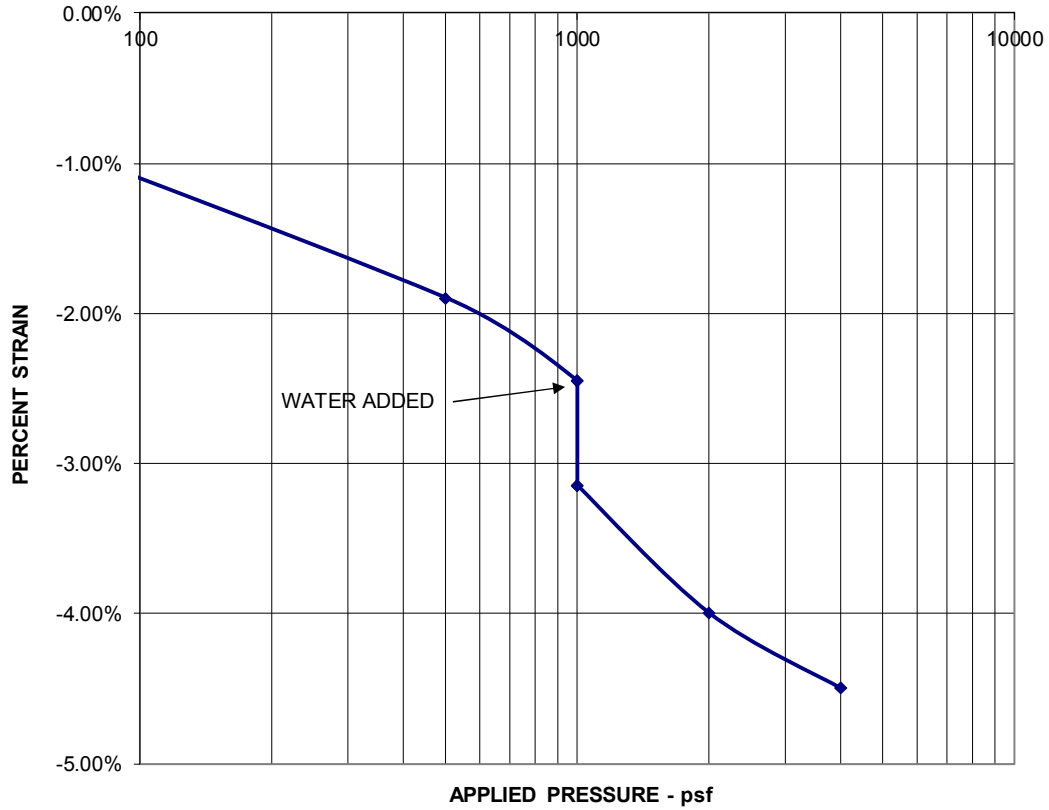
Job Number	Job No.4812 Spocket Subdivision	
Sample Source	TP-2 at 2 ft	
Sample Description	CL-ML	
Natural Dry Density	104.1 pcf	88% Relative Compaction
Natural Moisture Content	23.3%	9.3% From Optimum
Saturated Moisture Content	21.6%

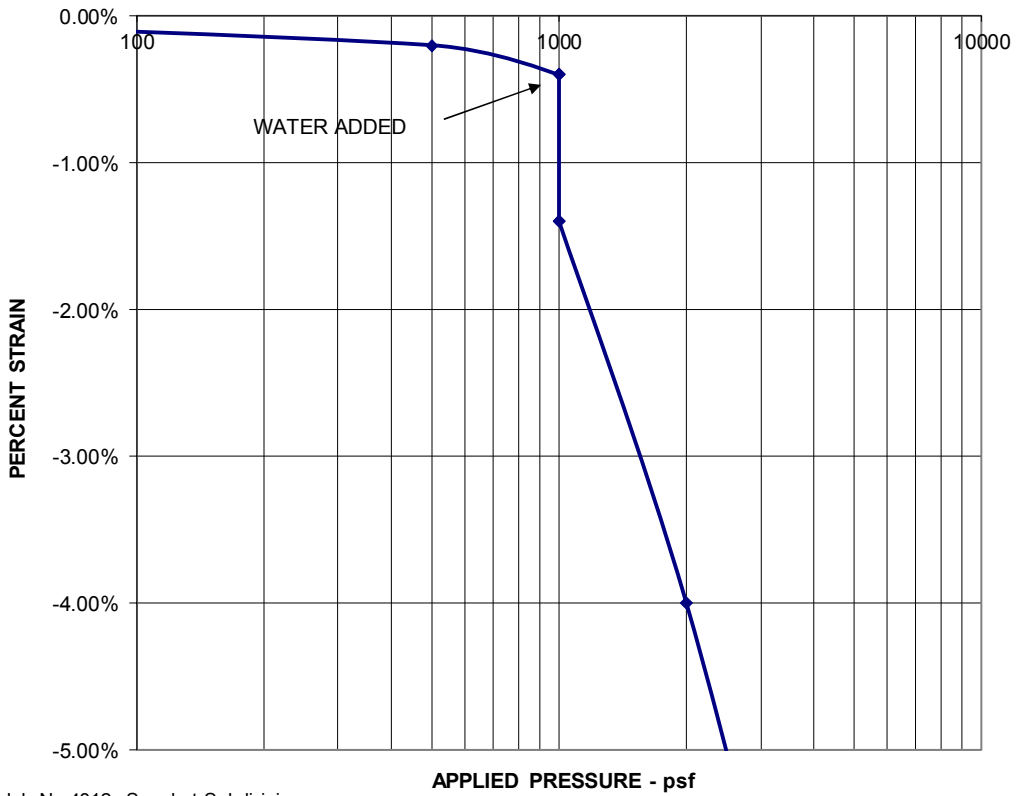
Job Number	Job No.4812 Spocket Subdivision	
Sample Source	TP-3 at 2 ft	
Sample Description	ML	
Natural Dry Density	97.8 pcf	82% Relative Compaction
Natural Moisture Content	9.9%	-4.1% From Optimum
Saturated Moisture Content	21.6%

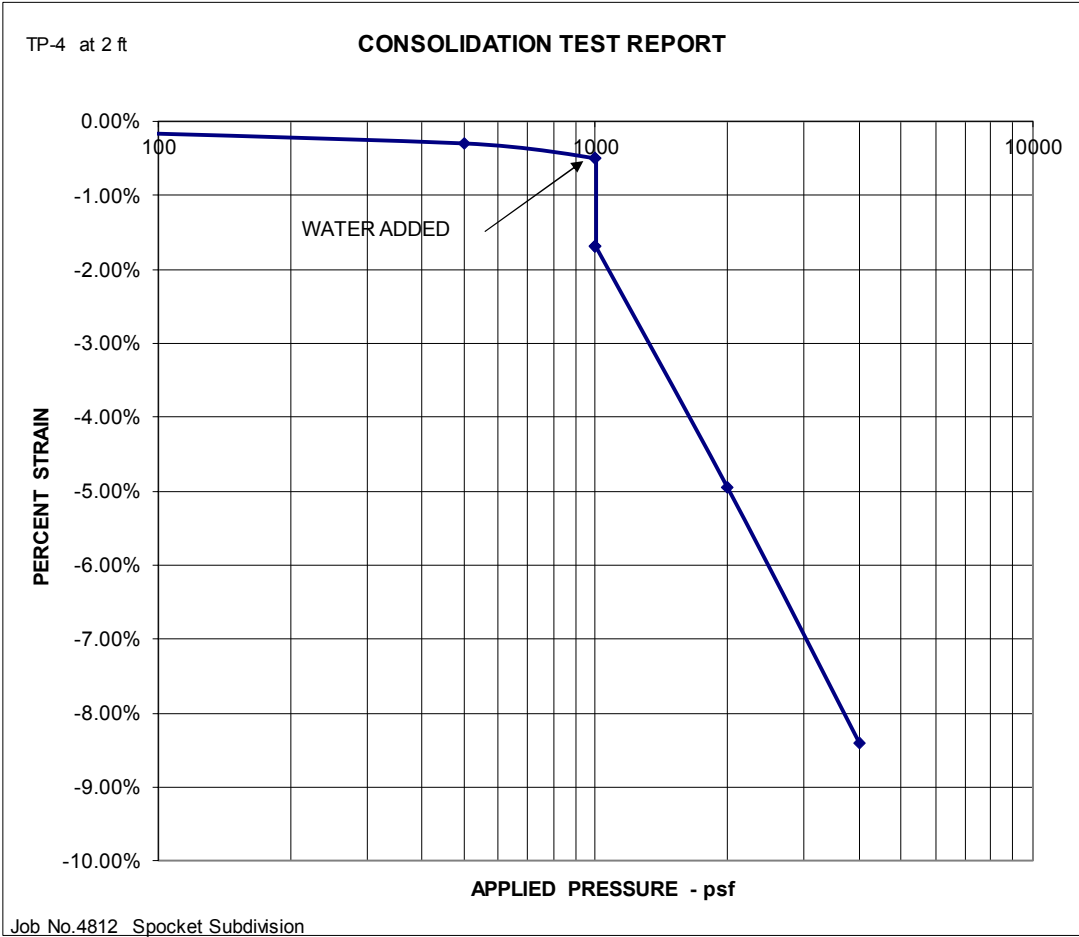
Job Number	Job No.4812 Spocket Subdivision	
Sample Source	TP-4 at 2 ft	
Sample Description	TP-1	
Natural Dry Density	96.6 pcf	81% Relative Compaction
Natural Moisture Content	10.6%	-3.4% From Optimum
Saturated Moisture Content	18.7%

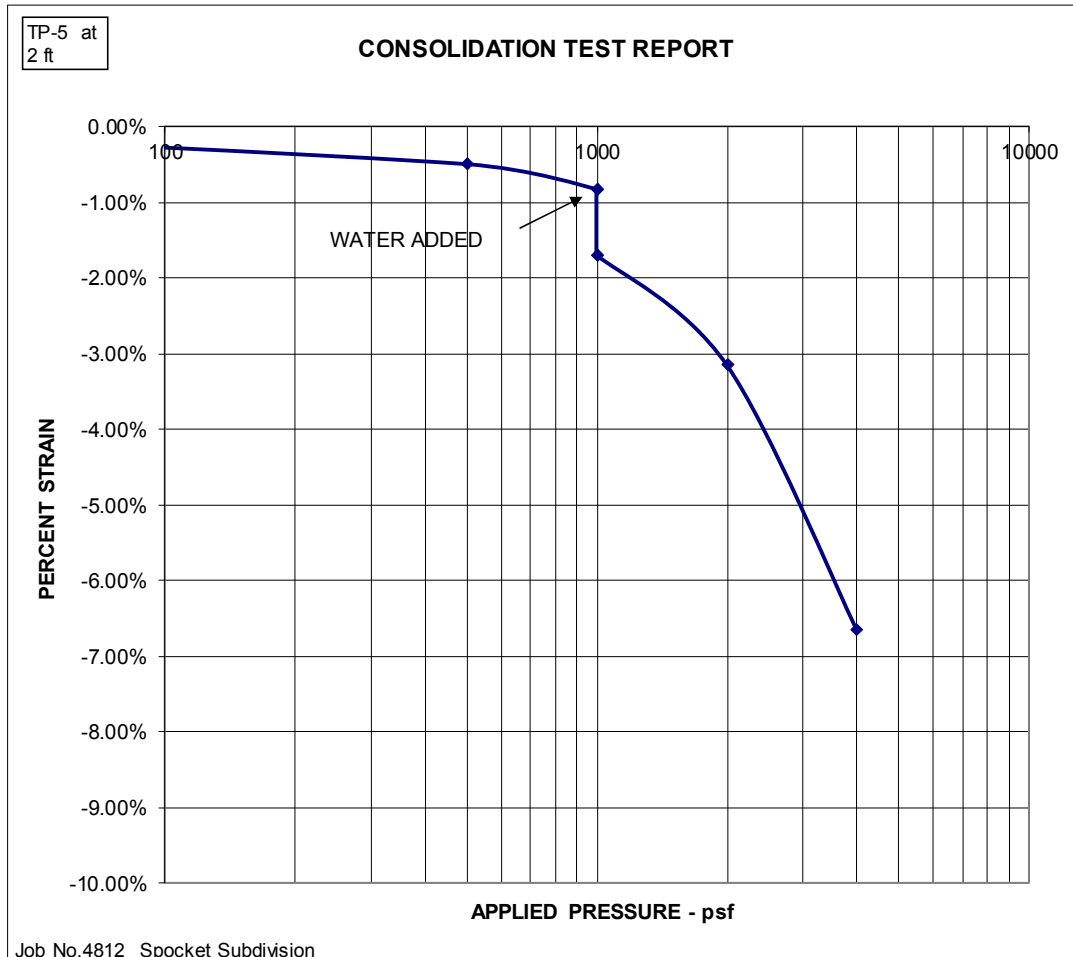
Job Number	Job No.4812 Spocket Subdivision	
Sample Source	TP-5 at 2 ft	
Sample Description	CL	
Natural Dry Density	102.4 pcf	86% Relative Compaction
Natural Moisture Content	8.7%	-5.3% From Optimum
Saturated Moisture Content	18.3%

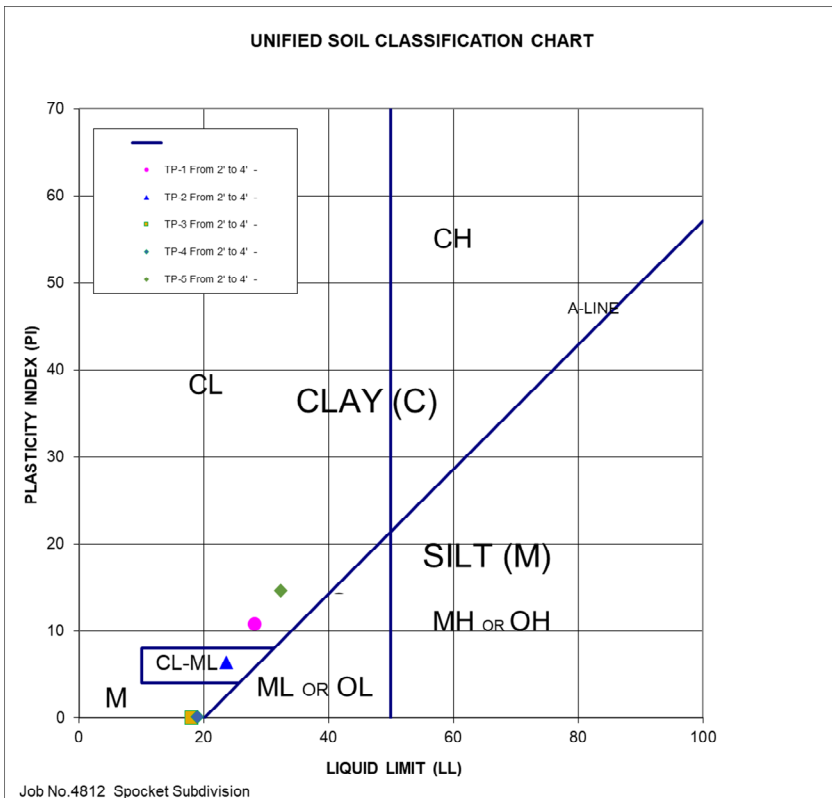
Test Pit	Depth	Liquid Limit	Plastic Limit	Plasticity Index	Description
TP-1	2-4'	28	17	11	Lean Clay
TP-2	2-4'	25	17	6	Clayey Silt
TP-3	2-4'		NP	NP	Silt
TP-4	2-4'		NP	NP	Silt
TP-5	2-4'	33	18	15	Lean Clay

These results indicate low to moderate swelling potential.

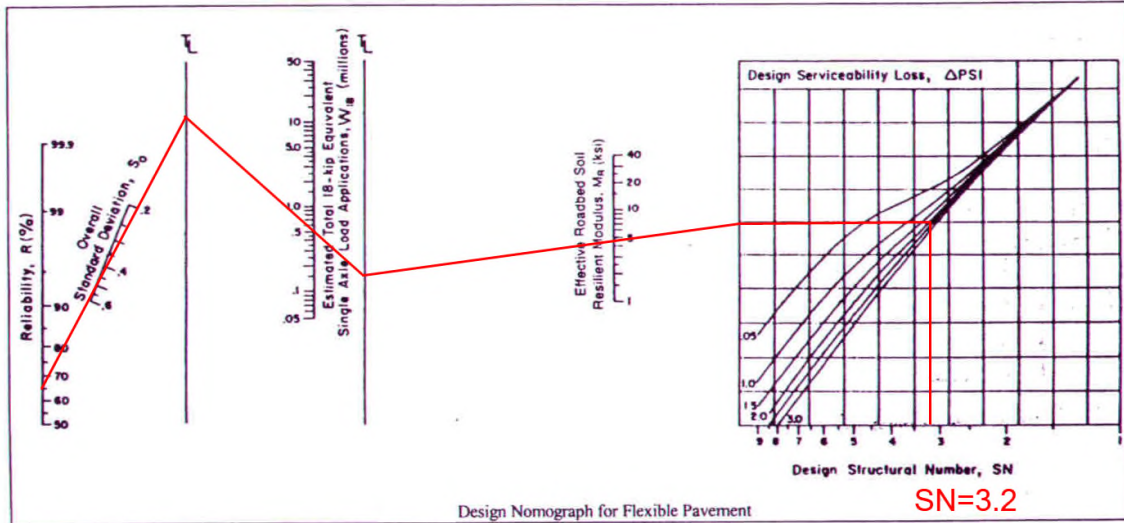
The CDOT- AASHTO nomograph design method was used to calculate the required Structural Number for each of the sections being studied. The nomograph is presented below. The required pavement section for the clayey silt (CBR-Value 5) is a structural number (SN) of 3.2 for the subdivision.

R-Value	18K-ESAL	RF	Sn	HMA	ABC	ASC
				0.44	0.12	0.10
5	500,000	85%	3.2	3.0	16.0	0
5	500,000	85%	3.2	3.0	6.0	12
5	500,000	85%	3.2	4.0	12.0	0
5	500,000	85%	3.2	4.0	6.0	8
